**BROAD BROOK DAM  
CT. 00301**

**PHASE I INSPECTION REPORT  
NATIONAL DAM INSPECTION PROGRAM**

SEPTEMBER 1978

Identification Number: CT 00301  
Name: Broad Brook Dam  
Town: Cheshire  
County and State: New Haven County, Connecticut  
Stream: Tributary to the Quinnipiac River  
Date of Inspection: July 25, 1978

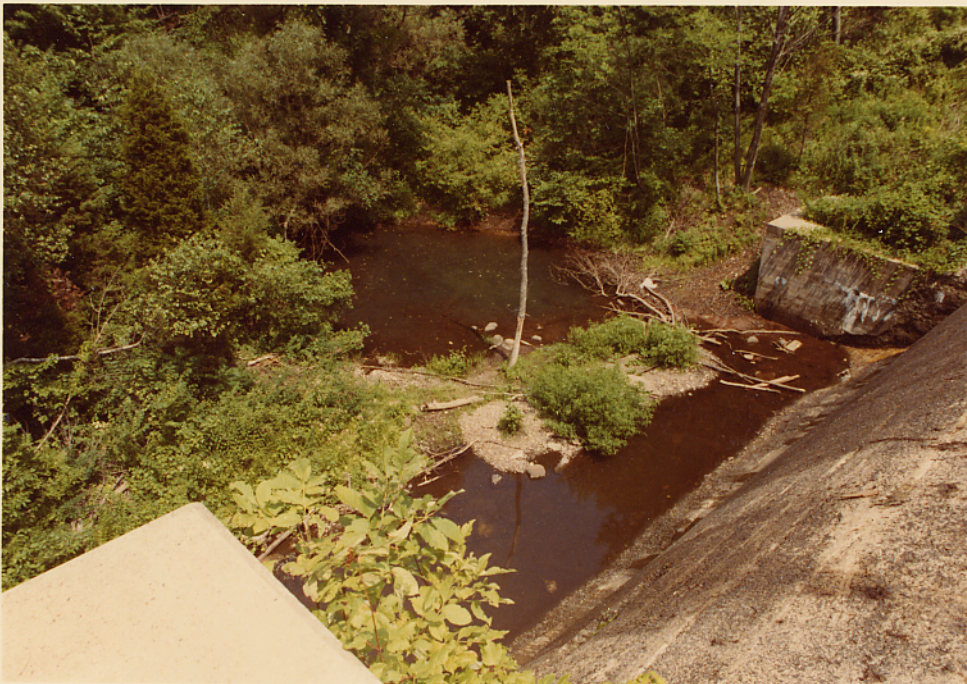
The river channel downstream is overgrown with trees and brush and is not conducive to the free passage of flood flows. This condition is found from the dam to the confluence of Broad Brook with the Quinnipiac River.

PHOTO 2  
DOWNSTREAM CHANNEL AREA

- a. Alternatives - Not applicable.
- b. O & M Maintenance and Procedures -
  - (1) The grass, brush and trees on the downstream slopes of the dam and banks at the distance of 300 feet from the dam should be removed to facilitate the visual observation of existing and potential seepage.
  - (2) Restoration of the existing drainage system in the body of the dam.
  - (3) The repair of the concrete faces of the dam with the removal of weak and deteriorated concrete.
  - (4) The downstream channel of the spillway should be cleaned of rock deposits, brush and trees so that overflow discharges from the spillway and the blowoff can be passed freely.
  - (5) A formal warning system should be developed including an operational procedure to follow in the event of an emergency.
  - (6) The flashboards that are on top of the spillway should either be repaired or removed.

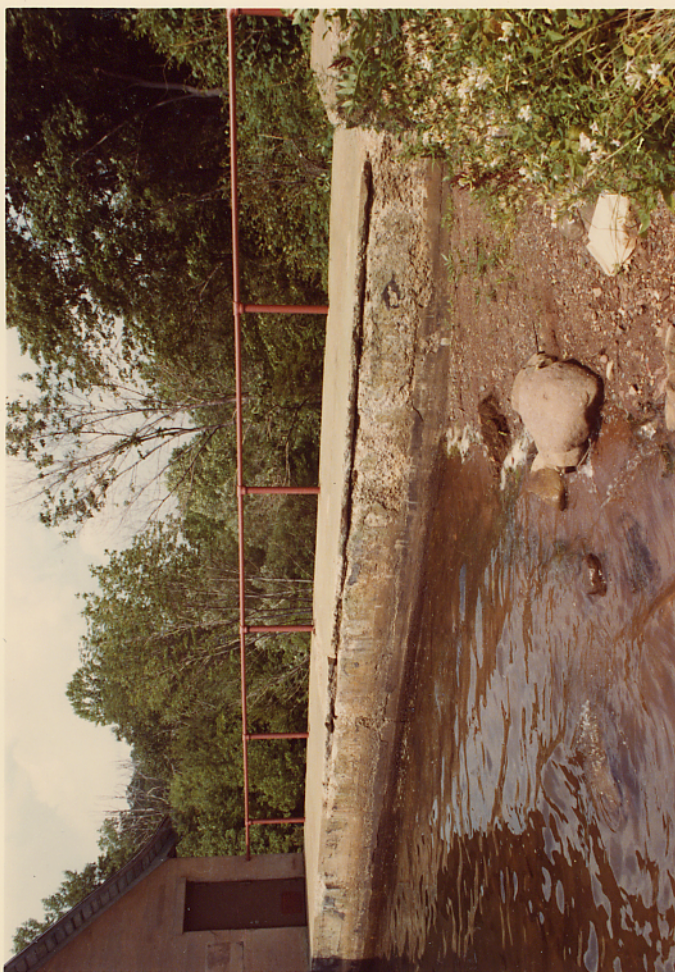
PHOTO 3  
DAMAGE TO UPSTREAM FACE OF DAM

4. Sketches and photographs of the damaged surfaces (caverns, erosion areas, cracks, rust reinforcement and spalling) of the top, upstream (with reservoir level lowered) and downstream slopes of the dam and the concrete walls of the gate house, yearly. There should also be a measurement of the depth and area of these distresses and the width of cracks.

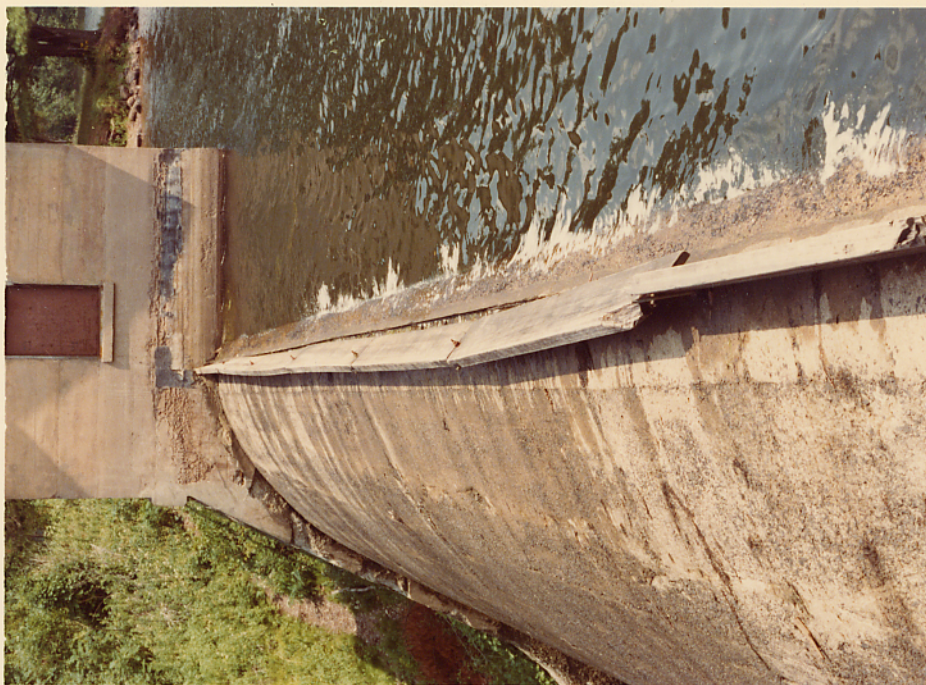
b. Dam - An inspection of the downstream face of the spillway revealed several areas which had spalled or showed signs of seepage. In one location on the west side of the spillway reinforcing bars were exposed. The concrete showed signs of distress to a depth of 2 to 4 inches, especially along the horizontal construction joints. The upstream face of the dam showed some signs of minor erosion and concrete spalling. A search for the four inch diameter outlet of the underdrain system that is shown on Plate 2, Appendix B, was not successful because of the considerable amount of silt deposited at the toe of the spillway. The wooden flashboards on the spillway were badly weathered and appeared useless.

PHOTO 4  
FLASHBOARDS ON CREST OF SPILLWAY

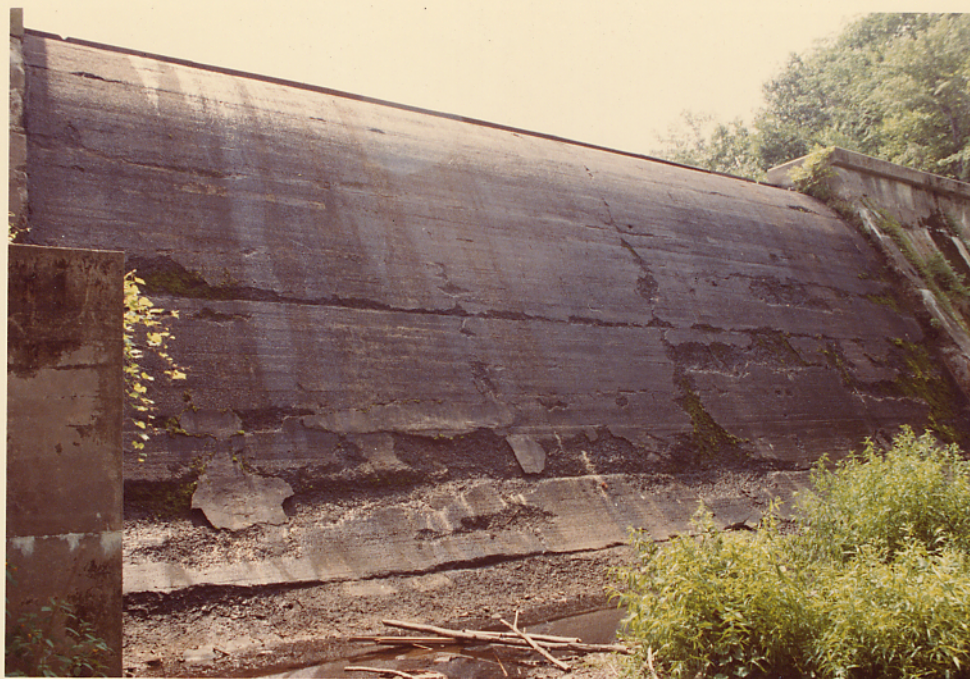
c. Visual Observations - The spillway at the time of the inspection was in poor condition with some evidence of water seeping through its construction joints (Appendix C, Photo 5).

PHOTO 5  
DOWNSTREAM FACE OF SPILLWAY

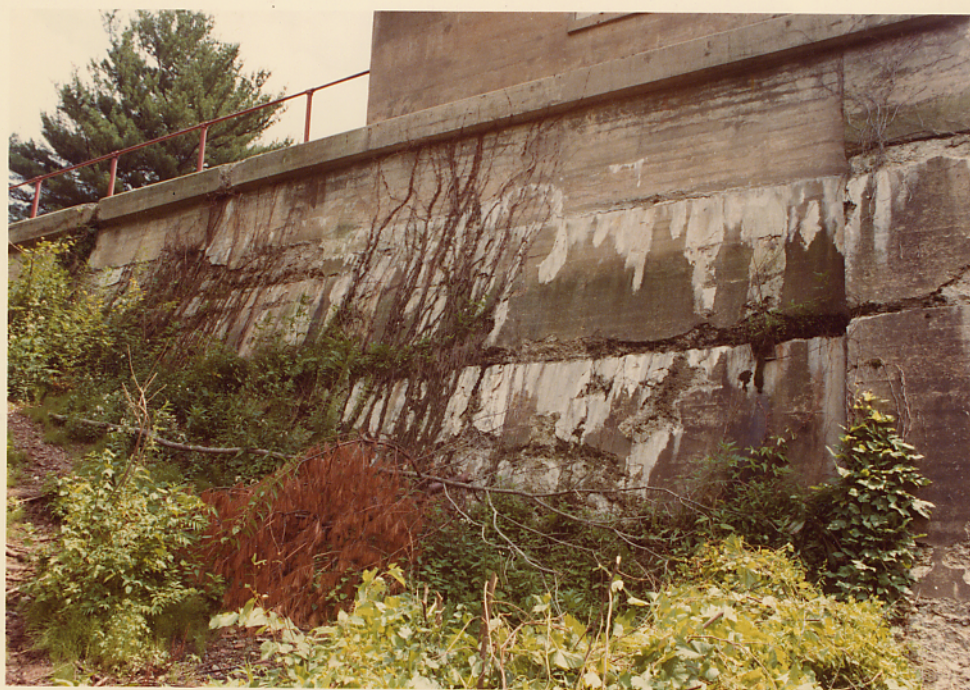
PHOTO 6  
SEEPAGE FROM FACE OF DAM

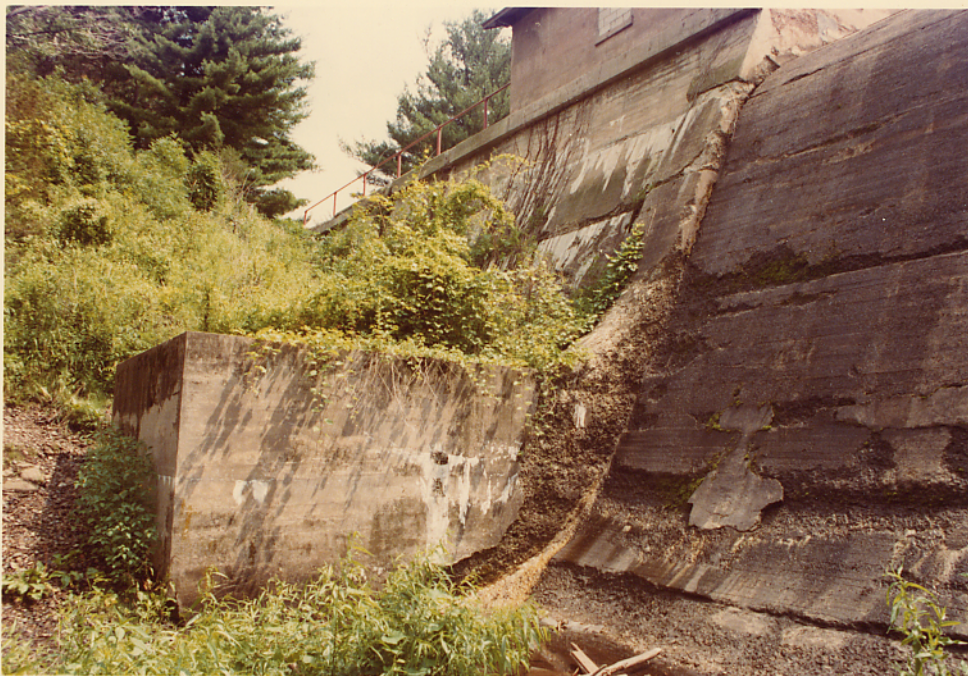
1. Considerable damage to the concrete face of the dam, especially along the horizontal construction joints of the downstream slope of the spillway.

There are erosion areas which are four inches deep with rusted reinforcement that is exposed (Appendix C, Photo 7).

PHOTO 7  
DAMAGE TO EAST FACE OF SPILLWAY AND MAIN DAM

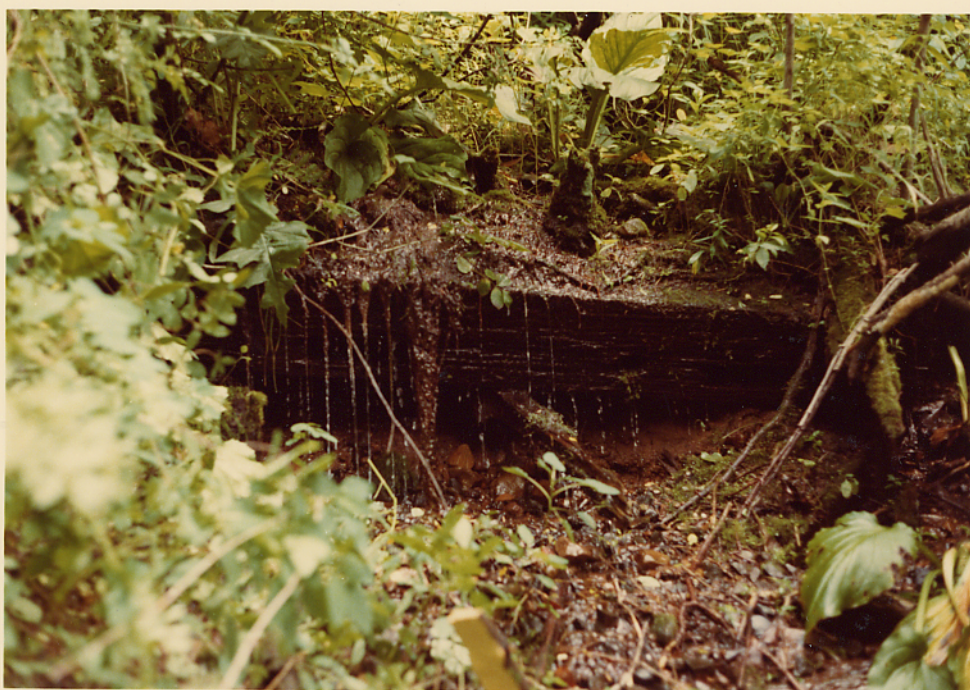
The east bank on the downstream side of the dam shows signs of fairly heavy seepage. This condition should be investigated further.

PHOTO 8  
SEEPAGE FROM EAST BANK OF DOWNSTREAM CHANNEL

Recommended measures to be undertaken by the owner include monitoring seepage, studying the overall condition of the dam (cracks, erosion and areas of distress), studying vibration during high flows and establishing an inspection program. The owner should implement the recommendations and remedial measures described in Section 7 within one year after receipt of this Phase I Inspection Report.
